Cable Dahmer Arena Facility Assessment

Final Report // February 24, 2022

The project entails the assessment of the existing conditions of the Cable Dahmer Arena at 19100 East Valley View Parkway in Independence, Missouri. The purpose of this study is to assist the Independence Events Center Community Improvement District Board in identifying immediate maintenance issues as well as to plan for potential future capital expenditures for the facility.

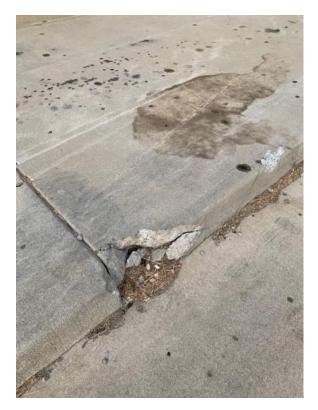
Image 4 – Spalling concrete at curb.

- 1. Spalled concrete at curb: Replace curb section. Match existing curb profiles.
- 2. Crack, 1/4" or greater: Replace sidewalk section, joint to joint.
- 3. Crack, ¼" or less: Replace sidewalk section, joint to joint.
- 4. Spalling at expansion joints: Sawcut, pour back, and install expansion joint along brick pavers.
- 5. Uneven joint greater than $\frac{1}{2}$ ": Replace sidewalk section on each side of joint and level.
- 6. Failed caulk joint: Replace 100%.
- 7. Spalling at control joint: Replace sidewalk section, joint to joint and install new control joint.
- 8. Spalling at bollard: Remove loose concrete and patch sections with greater than 2" diameter loss.
- 9. Spalling at stairs: Remove loose concrete and patch repair tread corners at stairs.
- 10. Spalling at dock curb: Remove loose concrete and patch repair dock curb.

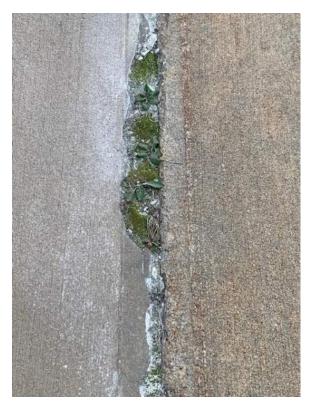
Image 5 – Spalling concrete at expansion joints.

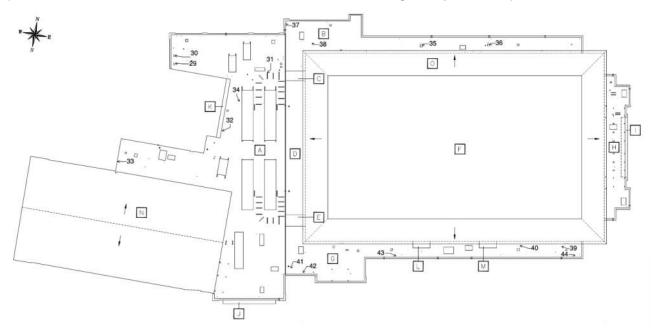
Figure 1 – Roof Plan Identifying Roof Areas (Not to Scale) – See Appendix B for enlarged plan.

The facility is constructed with fifteen separate roof areas. The roof system on thirteen of the roof areas is a single ply roof membrane (areas "A" – "M") consisting of approximately 84,562 square feet. Existing documentation provided to our office indicates the single ply roof membrane areas have the following components:

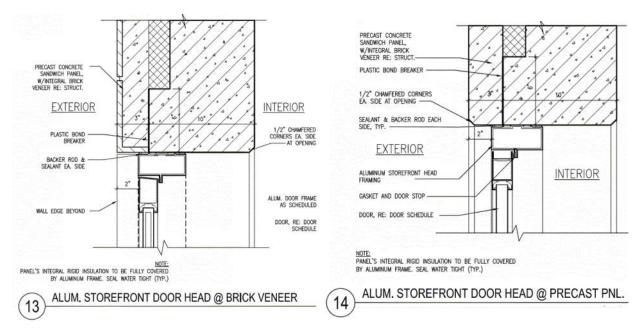
The exterior wall surfaces are composed of 13" thick precast concrete sandwich wall panels (with integral rigid insulation covered with aluminum frame); thin brick veneer in a running bond pattern with buff-colored mortar; integral buff-color stucco walls and soffits at the upper bowl; and prefabricated metal parapet caps, gutters and downspouts (see roofing section for caps, gutters and downspouts).

Image 11 and Image 12 – Typical wall details showing precast panels and brick veneer assembly at aluminum storefront door heads (11/20/08 Construction Set).

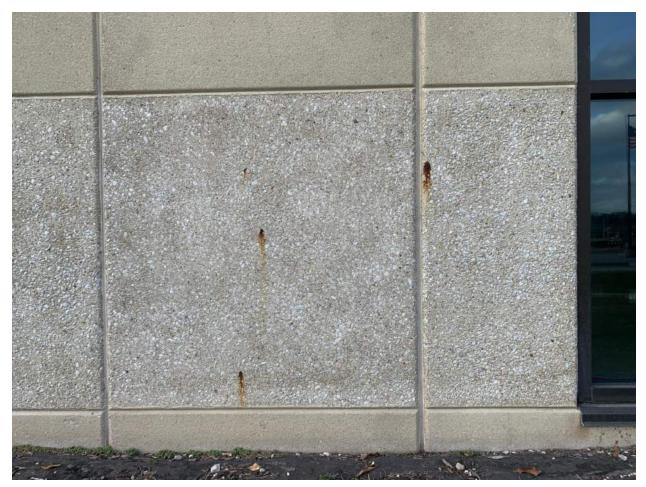
Image 15 – Precast concrete panels with rust staining.

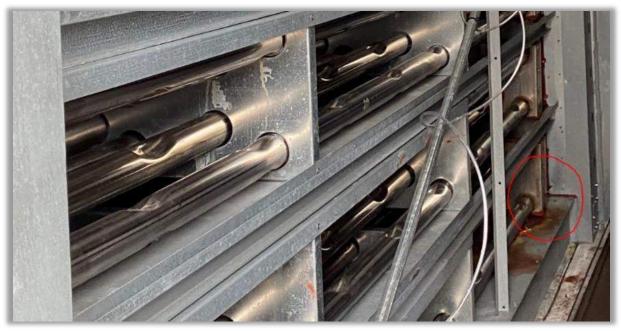
Burner Condensate Leakage: There were signs of condensate leakage from the natural gas burners. The picture below shows one of the larger RTU burners that has leaked, and the leaks have been sealed with the red caulking shown. However, caulking the leaks is a temporary fix that will continue to have to be monitored and maintained. Over time, the corrosive condensate will continue to make these leaks worse resulting in combustion gases from the burner making their way into the air stream instead of the flue.

Image 20 – One of the larger RTUs that has leaked.

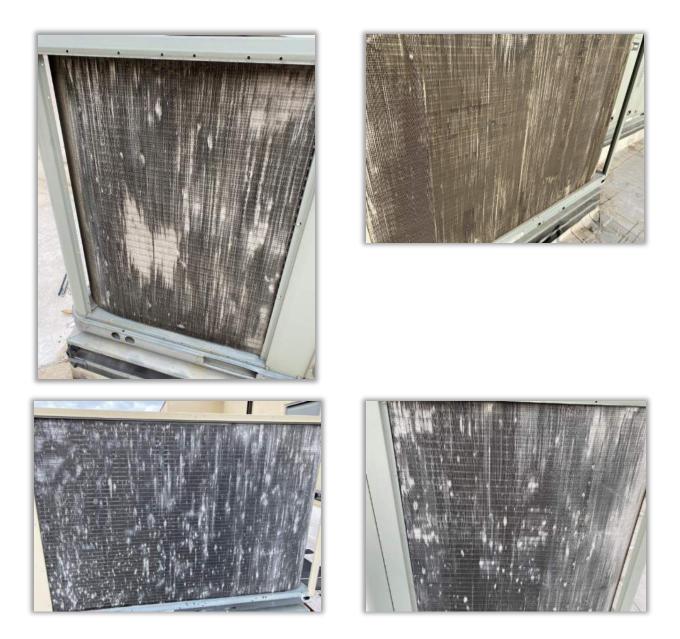
• Damaged Condenser Coils: The majority of the condenser coils on the RTUs were found to be damaged by the weather (i.e. hail) and dirty. The damage to the coil fins and the dirt/debris limits the condensers' ability to remove heat from the refrigeration circuit resulting in a less efficient cooling system and longer run times for the compressors and fans shortening their service life.

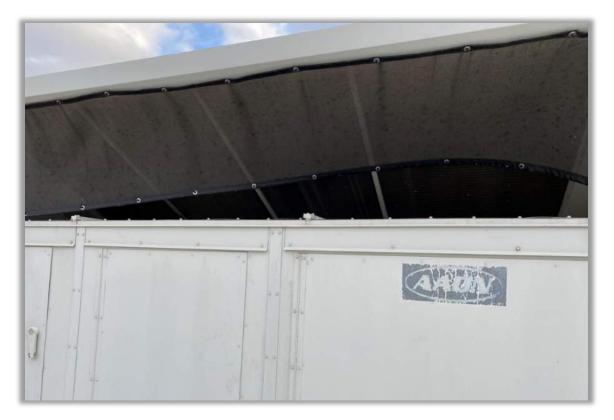
- RTU-24-4: This unit serves the Community Ice Rink and the maintenance technician indicated this unit seems to operate nonstop which may be a sign it is undersized.
- RTU-31-1 & RTU-33-1: The facilities staff feels these units are undersized since they have to close the outside air dampers in the summer months in order to provide enough cooling.
- RTU-33-2 & RTU-33-3: The facilities staff said that these units should be flip-flopped. They believe RTU-33-2 is undersized and RTU-33-3 is oversized.
- RTU-25-3: The bird/hail screen for the condenser coil has fasteners that have been disconnected from the unit limiting the protection of the coil (see picture below).

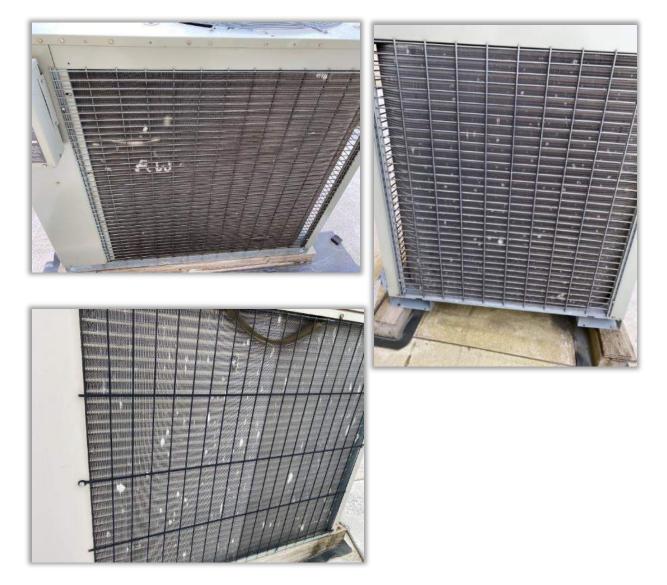
Damaged Condenser Coils: The majority of the condenser coils for the air conditioning units were found to be damaged by the weather (i.e. hail) and dirty. The damage to the coil fins and the dirt/debris limits the condensers' ability to remove heat from the refrigeration circuit resulting in a less efficient cooling system and longer run times for the compressors and fans shortening their Service life.

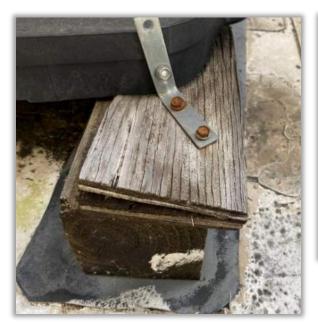
• Deteriorating Base Supports: The 4"x4" wood base supports for condensing units CU-31-2 and CU-32-2 were found to be significantly deteriorated. This deterioration keeps the conditioning unit from being level. Multiple issues can occur if the condenser is not level. These issues include damage to the fan motor, trapped oil/refrigerant, excess vibration, etc. that all result in shortening the life of the air conditioning unit.

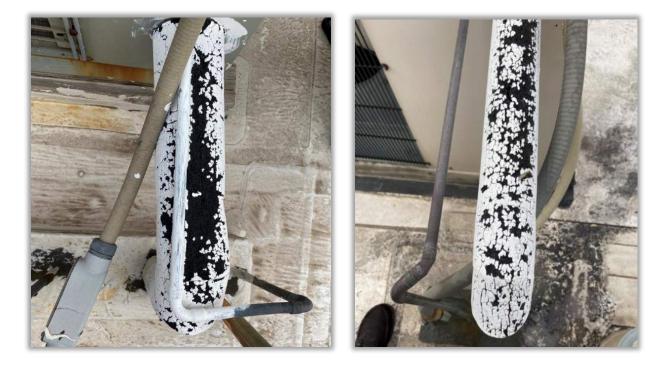
• Refrigerant Piping Insulation: The exterior refrigerant piping insulation coating/paint has begun to flake off exposing the insulation to the sunlight (UV rays) and weather. This exposure has resulted in deterioration of the insulation that will continue to increase over time.

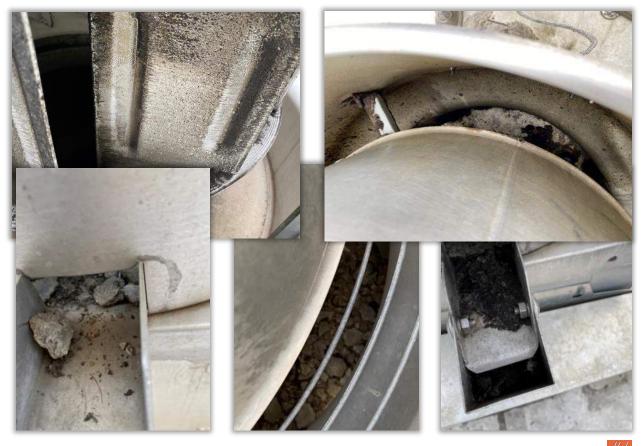
Grease & Debris Build Up: EF-21-1 that serves the Commissary Kitchen Exhaust Hood was found to have grease built up on its fan blades. EF-21-2 that serves the Commissary Dishwasher Exhaust was found to have debris in the fan that may have come from hard water/minerals/chemicals in the dishwasher exhaust stream. EF-32-2 that serves the Grille Exhaust Hood Event Level had grease build up in the fan housing because the grease drain looked to be clogged.

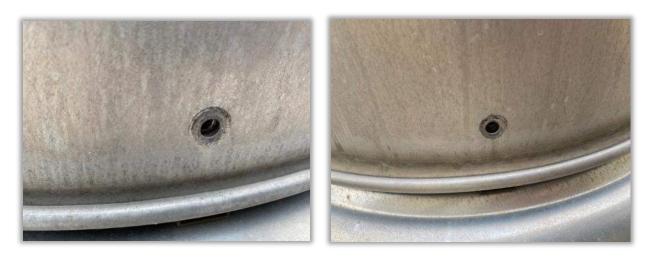
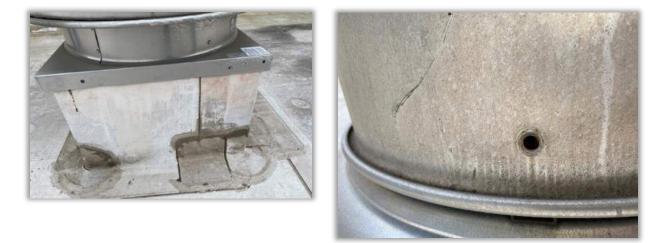
• Missing Fasteners: Some of the fasteners for the fan's housing and curb were found to be missing on EF-21-3, EF-21-4, EF-25-1, EF-32-3, and EF-33-2.

<u>Remaining Life</u>: The ASHRAE Handbook – HVAC Applications show a Median Service life of 20 years for Fans Ventilating Roof-Mounted. However, factors such as exposure to extreme weather (i.e. - hail, wind, temperature changes), run times, etc. can decrease the Median Service life. The Exhaust Fans are approximately 13 years old and still have 5-10 years of useful life left based on their age and condition.

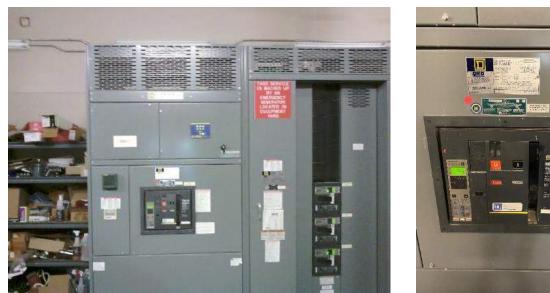
Normal Power Distribution The main electrical switchboards are located within a dedicated space adjacent to the utility service yard. Each main breaker is rated for 4000A at the service voltage. MSB1-1 feeds the larger process loads (mechanical roof top units and ice systems) and MSB1-2 feeds the lighting, receptacles and smaller mechanical loads throughout the facility. Distribution of the electrical equipment is separated into four quadrants on the concourse level around the perimeter of the main arena.

Image E-002 (left): MSB1-1 with single distribution section Image E-003 (right): MSB1-1 Main Circuit Breaker

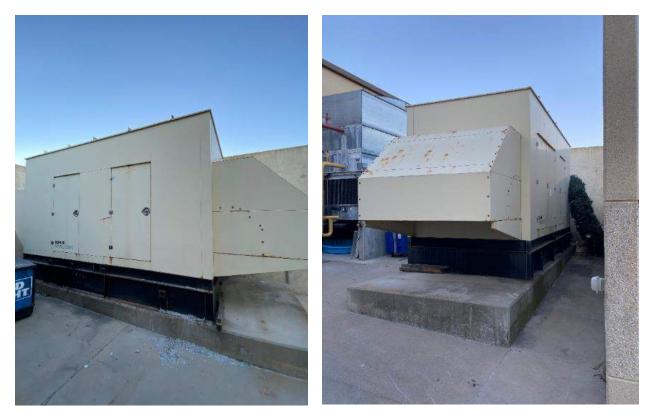
Image E-006 (left): Emergency Generator in service yard. Image E-007 (right): Emergency Generator air intake opening.

<u>Remaining Life</u>: Overall, the emergency generator and transfer devices are in good condition. The exterior housing of the generator is starting to show some wear from the exterior elements. At approximately 13 years of service life, the equipment is halfway through the life expectancy of 25-30 years under standby operating conditions. According to facility management, the generator is started weekly and runs for an hour for general maintenance. As part of this facility assessment, the generator was put under a 4-hour load bank test to raise the generator set up to operating temperatures and capacity. The results of the testing are shown in Appendix D. The generator was found to be in good working order and passed test requirements.

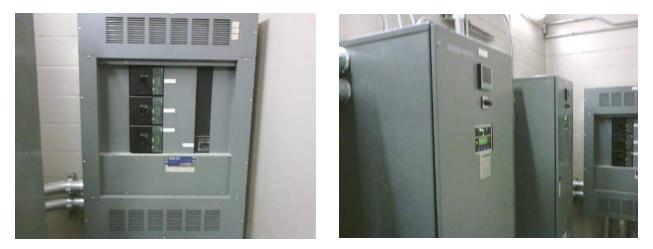
Image E-008 (left): Generator Distribution Board-GDP with (4) breakers for transfer switches Image E-009 (right): Automatic Transfer Switches: ATS-1 and ATS-2

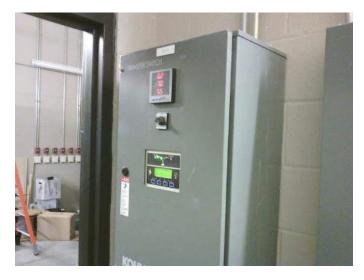
Image E-010 (left): Automatic Transfer Switch: ATS-3 Image E-011 (right): Manual Transfer Switch: MTS-1

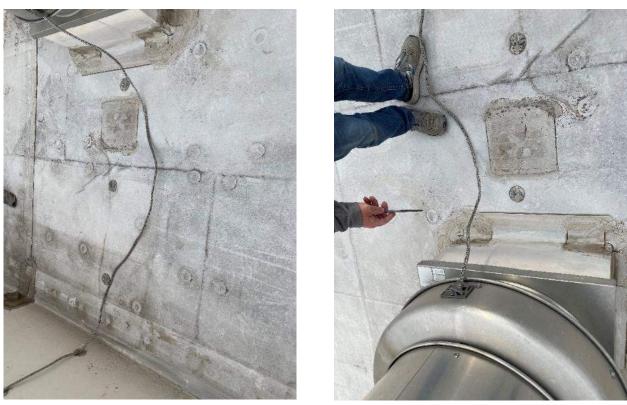
Image E-014 (left): Lightning Protection conductor free from Roof Cable Holder

Image E-015 (right): Lightning Protection conductor free from Roof Cable Holder at Exhaust Fan

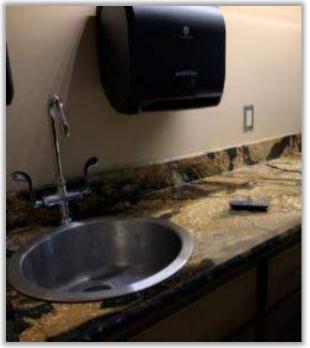
Figure P-10

• Suites: Each suite includes one beverage sink that is equipped with a 2.2 GPM manual faucet. Visual inspection of the sinks did not reveal any issues and they appeared to be in good working condition.

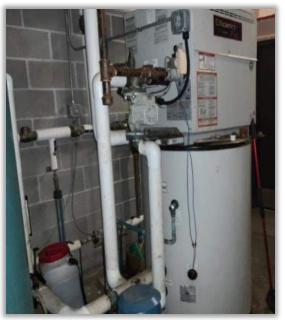
Figure P-12

<u>Remaining Life</u>: There is no published data on the lifespan of water heaters similar to the mechanical equipment in the ASHRAE Handbook. However, there are various estimates out there and on average the lifespan of a storage tank-type water heater is 8-12 years. Both water heaters are approximately 13 years old and have exceeded their estimated lifespan, however, we do not recommend replacing these heaters at this time since they were found to be in good condition.

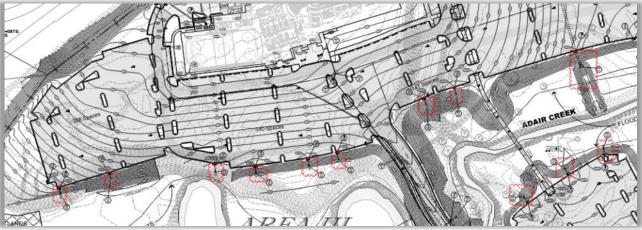
Figure P-13

Parking Lot Storm Drain System The facilities staff asked us to investigate the parking lot storm drain system outlets. The outlets discharge water over a bed of rip rap, or rock. Over time, the rip rap has eroded away resulting in significant erosion. The storm drain outlets that were inspected are bubbled in red in the drawing below. The following pictures show some of the erosion issues.

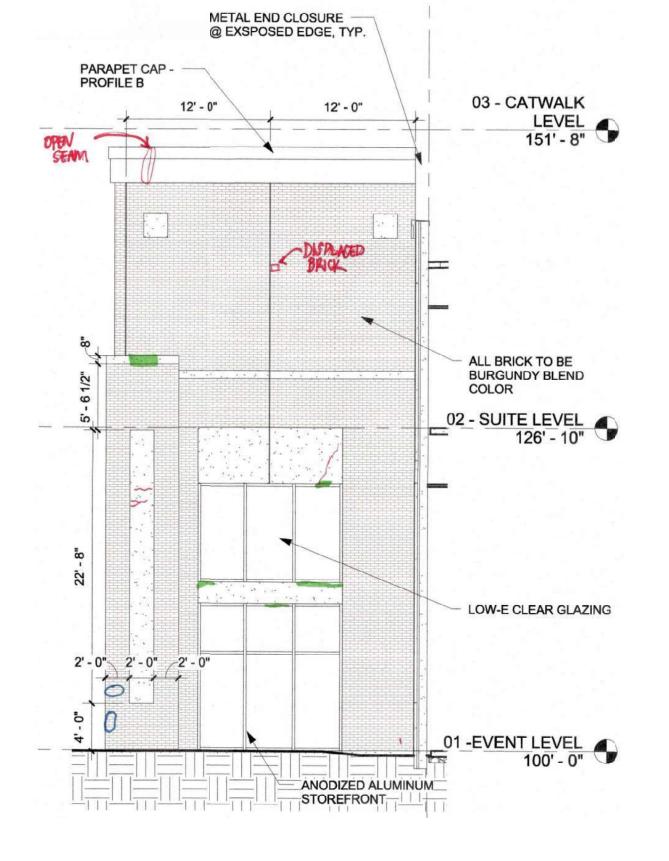
East & West Elevations @ South Entry CABLE DAHMER FACILITY ASSESSMENT | 02/04/22

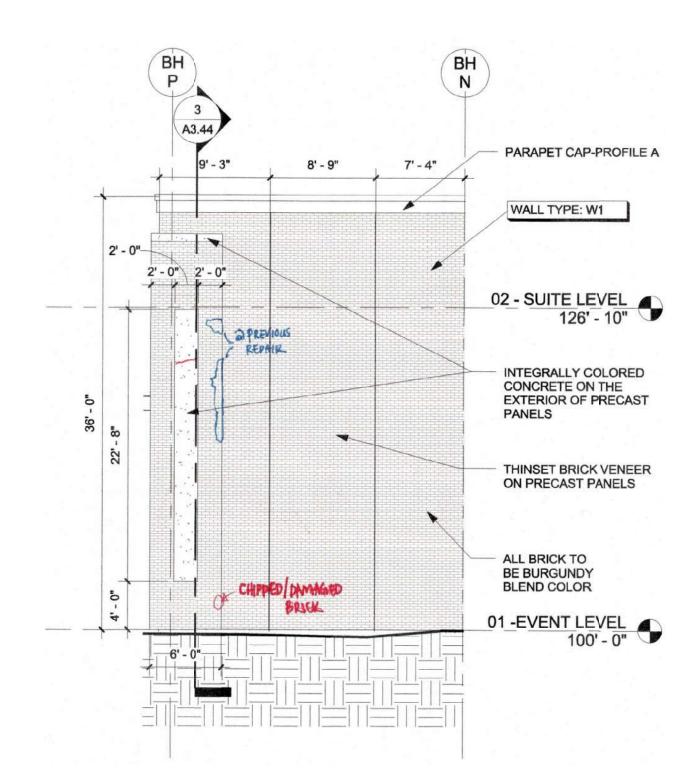
East Elevation @ Community Ice Entry CABLE DAHMER FACILITY ASSESSMENT | 02/04/22

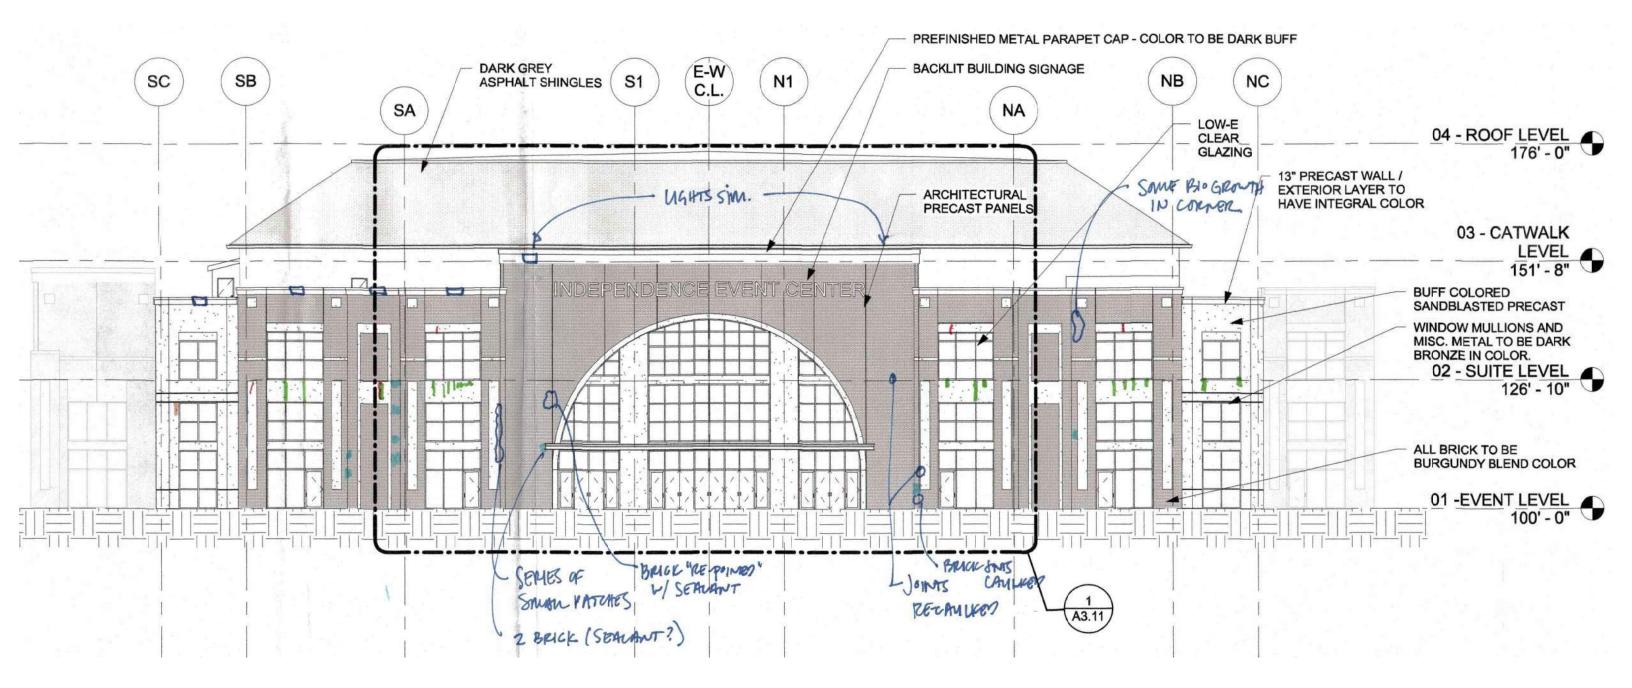
East Elevation CABLE DAHMER FACILITY ASSESSMENT | 02/04/22

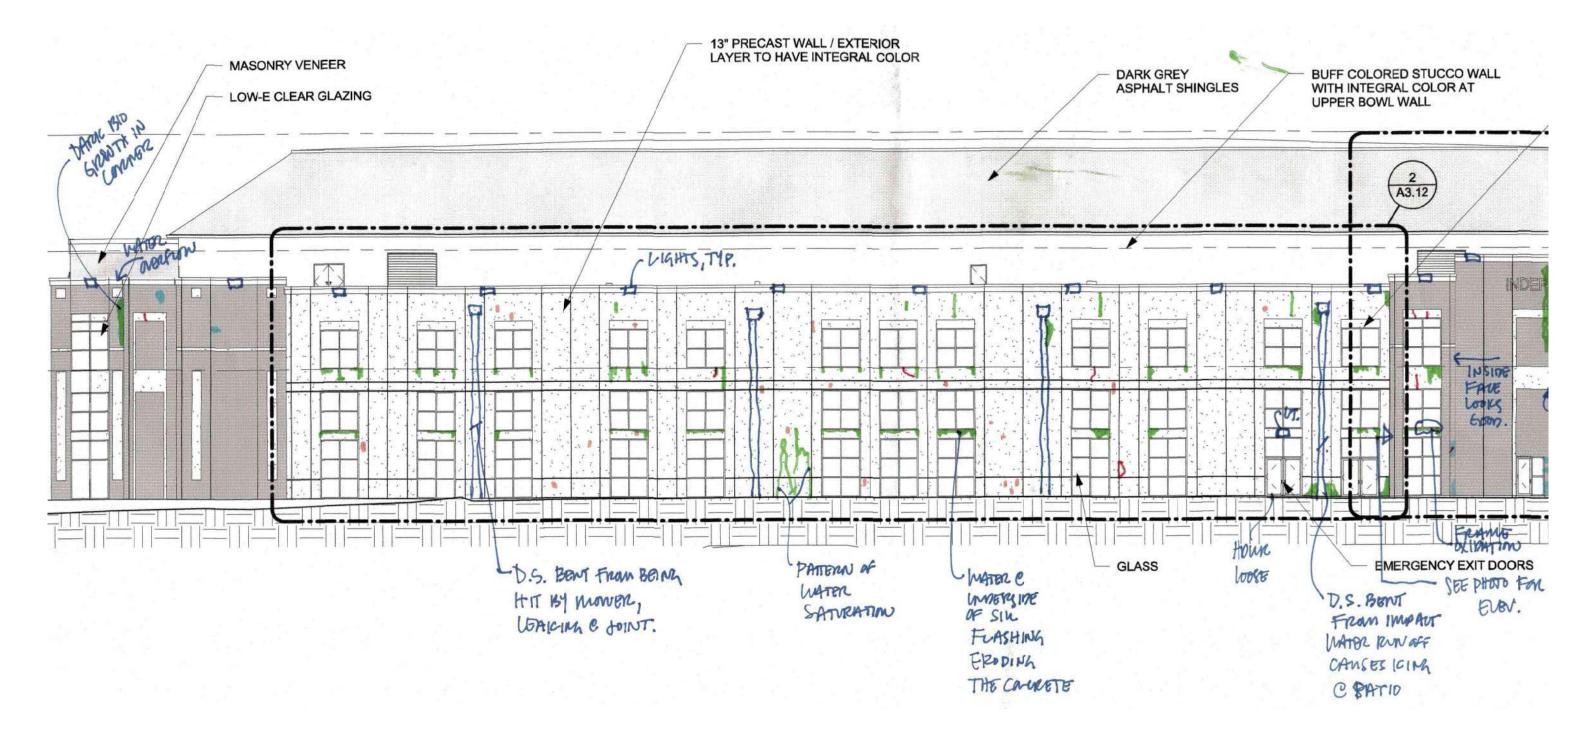
North Arena Elevation - East Half CABLE DAHMER FACILITY ASSESSMENT | 02/04/22

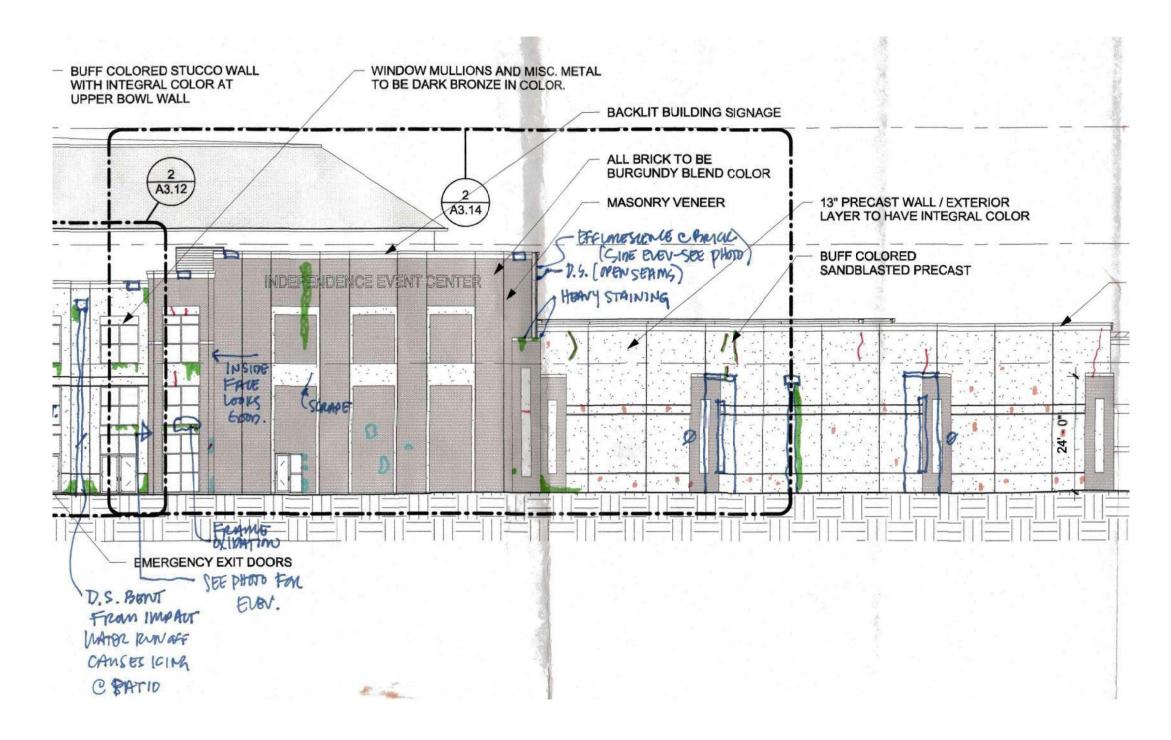
North Arena Elevation - West Half CABLE DAHMER FACILITY ASSESSMENT | 02/04/22

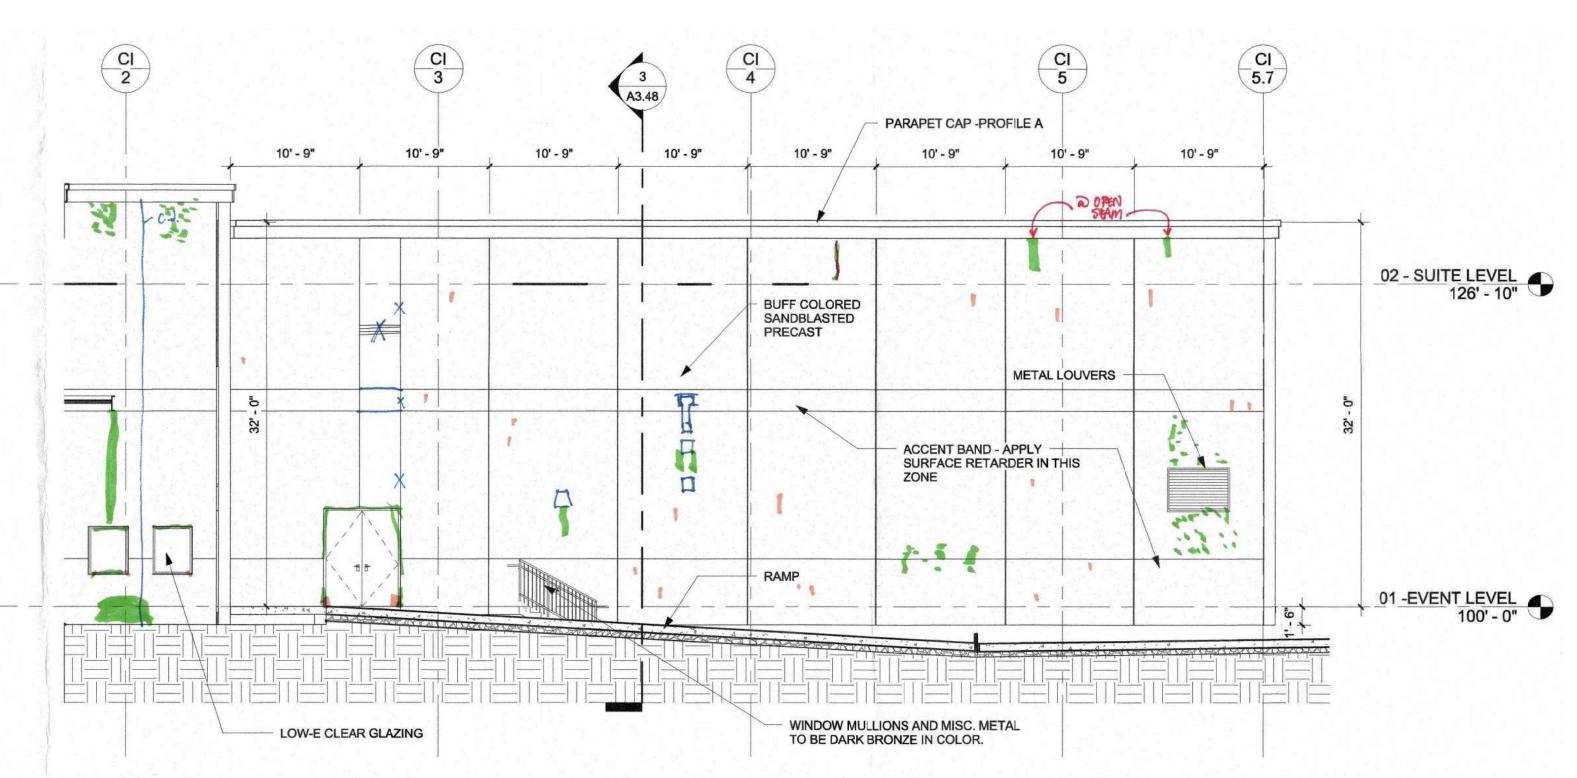
North Elevation @ Loading Dock CABLE DAHMER FACILITY ASSESSMENT | 02/04/22

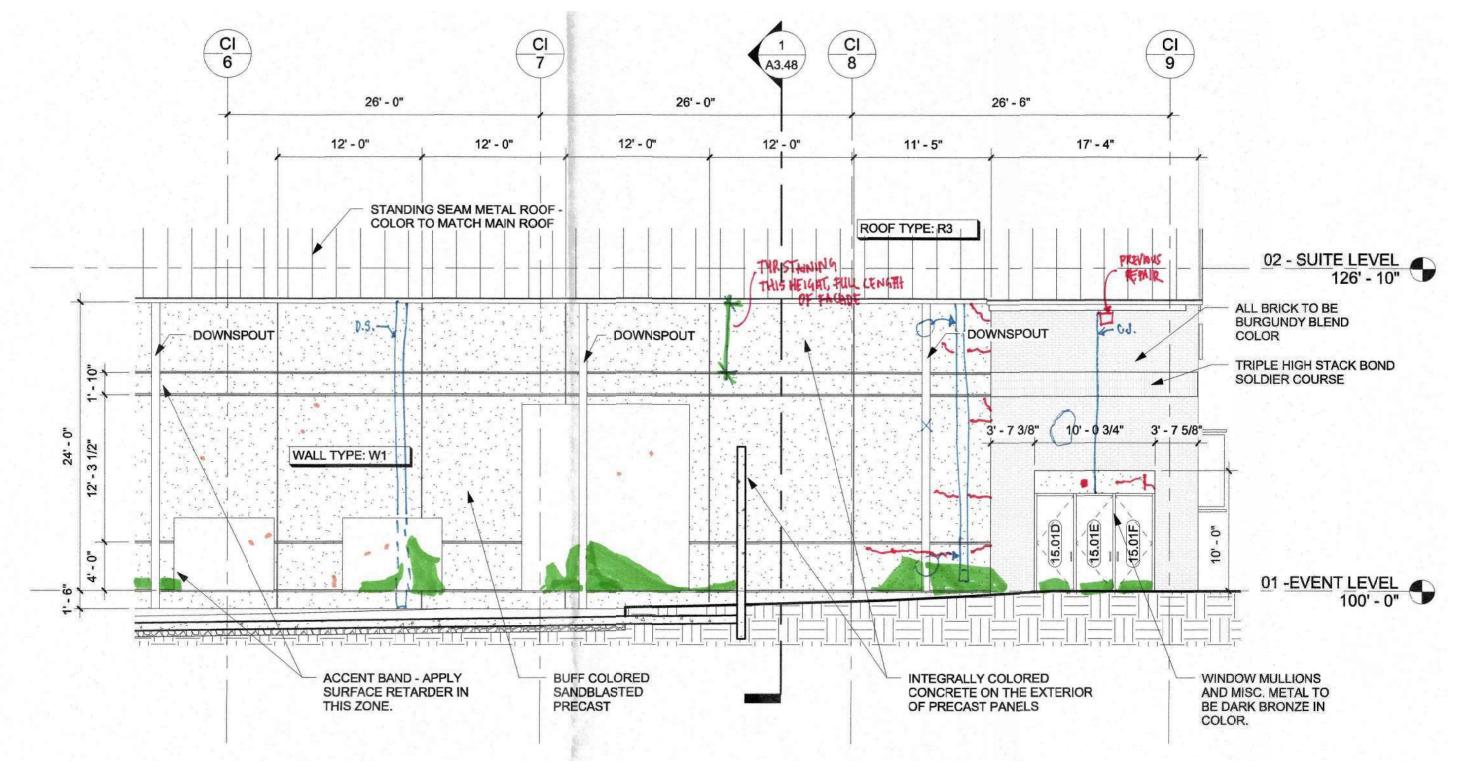
North Exterior Elevation @ Community Ice CABLE DAHMER FACILITY ASSESSMENT | 02/04/22

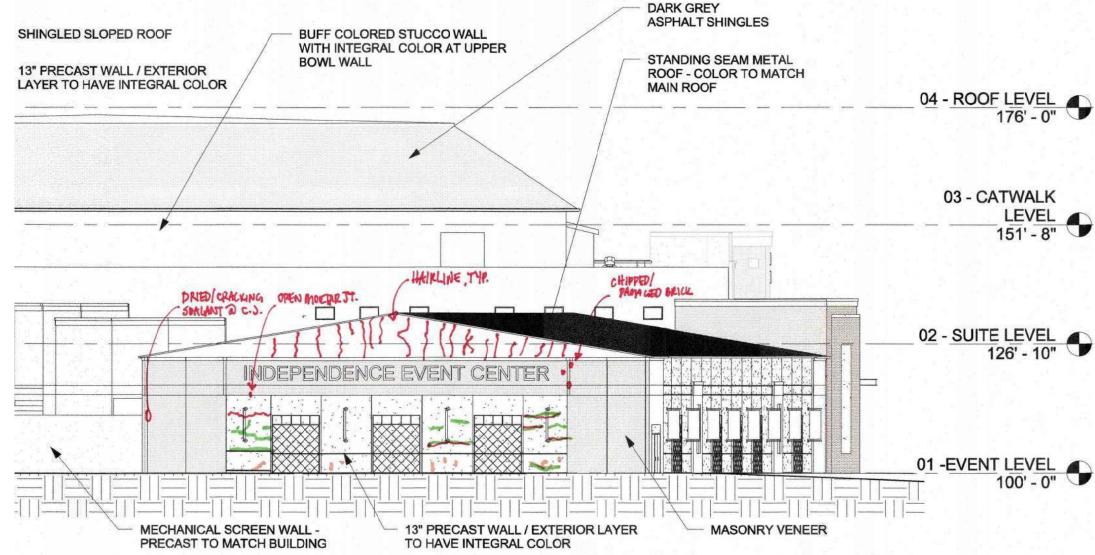
West Elevation @ Community Ice CABLE DAHMER FACILITY ASSESSMENT | 02/04/22

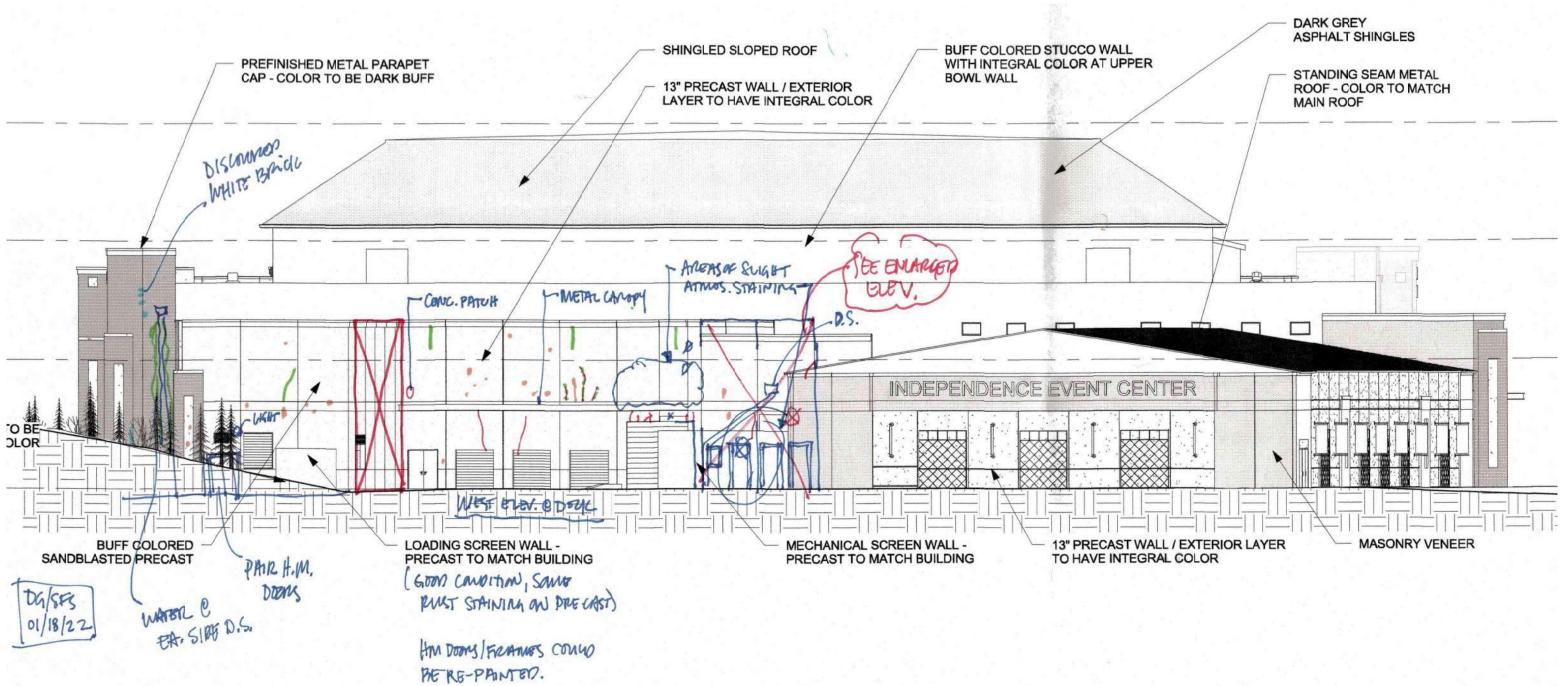
West Elevation CABLE DAHMER FACILITY ASSESSMENT | 02/04/22

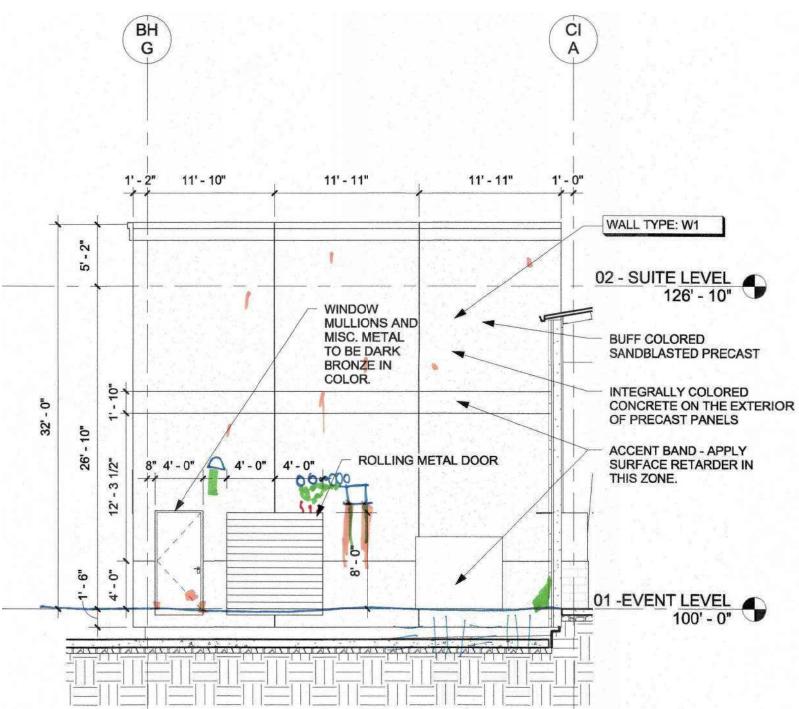
West Exterior Elevation @ Ice Chiller CABLE DAHMER FACILITY ASSESSMENT | 02/04/22

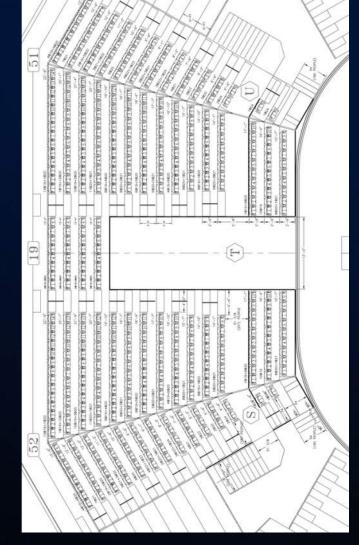
West End Zone Telescopic Platform

- 478 Metro Seats on MXP Telescopic Platform
 - Hinged Steel Gap Closures
 - Stair Units for Egress
 - Dasher Filler
- Polyvinyl walking surface
- Padded Seats and Backs with Spradling Zander vinyl fabric
 Semi-Automatic operation with das
- Semi-Automatic operation with gas strut lift assisted mechanism

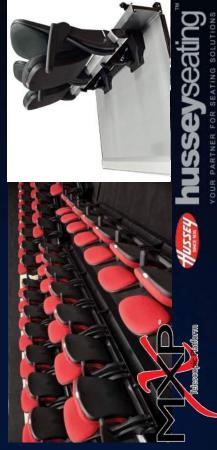
ALT - Sidelines & East End Zone Telescopic

- 1,132 Metro Seats
- Padded Seats and Backs with Spradling Zander vinyl fabric
- Semi-Automatic operation with gas strut lift assisted mechanism
